# Alteration Processes and Deterioration Phenomena of Faience Tiles in the Complex of King Djoser at Saqqara, Egypt

Keywords: Alteration processes; Faience tiles; Step Pyramid; Mortars.

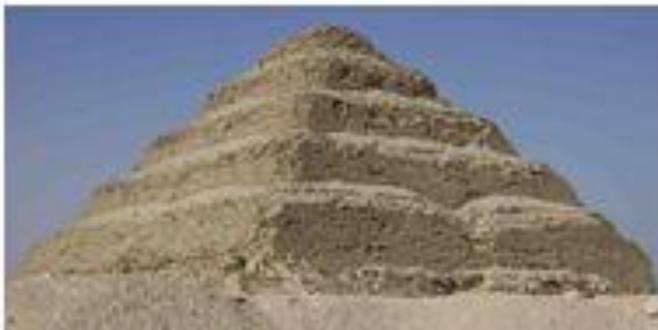
Fig. 2 shows the Step Pyramid at Saqqara

During the Third dynasty of Egypt, the architect Imhotep built Egypt's first step pyramid, the Pyramid of king Djoser at Saqqara by building a series of six successively smaller mastabas (an earlier form of tomb structure) one on top of another (fig. 2). Faience tiles were used to cover some of the walls of the substructures of the Step Pyramid and the so-called "South Tomb" (fig. 3), (fig. 4 a,b). The faience tiles suffer from many deterioration phenomena such as disintegration from stone supported walls, cracks, decay of mortars, crystallization of salts, missing parts from glazed layer besides loose and fall of many faience tiles from the walls. The rising damp in the supported walls and crystallization of soluble salts consider the main deterioration factors. The transformation of moisture involving variety processes such as absorption, evaporation, diffusion and capillarity as well as the surface tension of the liquid (Oliver, 1997; Charola 2000). Failure of faience tiles is most commonly water related where the ceramic units are highly susceptible to glaze cracking, spalling and material losing (Wilson, 1984). Different analytical methods used to obtain useful information about determination the chemical composition and microstructure of the faience tiles in order to

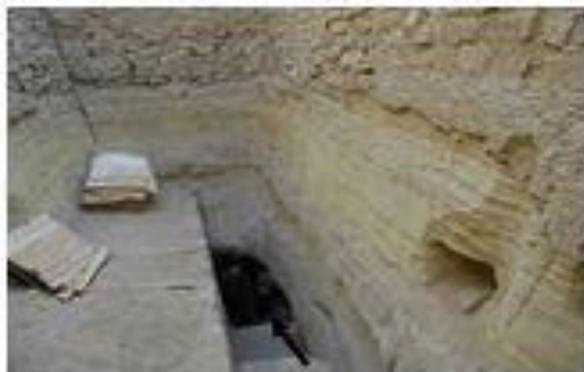
Fig. 3 shows entrance of South tomb of King Djoser at Saqqara .

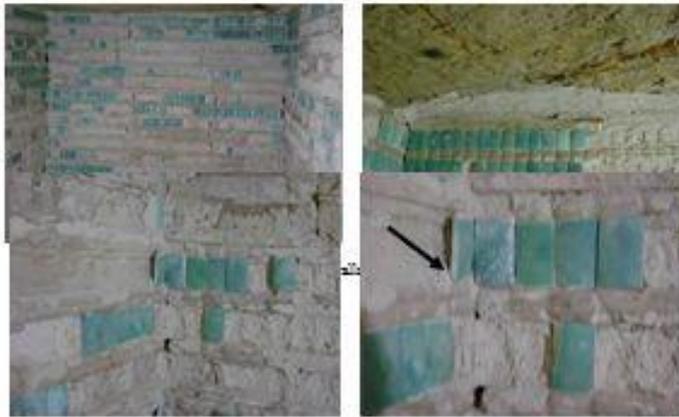
The faience tiles suffer from high alteration including failure and fragile of the binding mortar which used to fix the faience tiles (fig. 5 a, b). The glazed surfaces in some tiles subjected to high fragile and flaking off resulted in detachment them from bodies of the tiles (fig. 6 a, b), in addition to changing of the colours of faiences because of high moisture and crystallization of salts in the supported walls (fig. 7). Colored glazes suffer from crazing and spalling which appears as small blisters on the surfaces as well as some tiles subjected to cracking (fig. 8). Furthermore failure and fragile of the binding mortar between the tiles. All previous deterioration phenomena have resulted of high moisture in the walls, salt crystallization and finally human negligence of the maintenance these faiences which due to fall of many of them from the supported walls (fig. 9 a, b).

Fig. 5a, b shows fragile and flaking of some faience tiles.

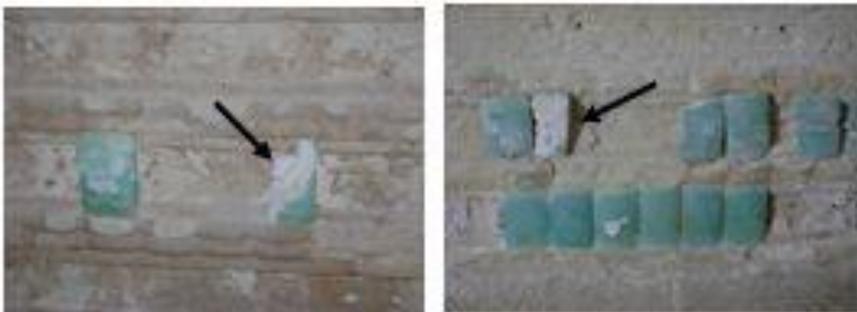
Fig. 6a, b shows missing of glazed layers and cracks in faience tiles.

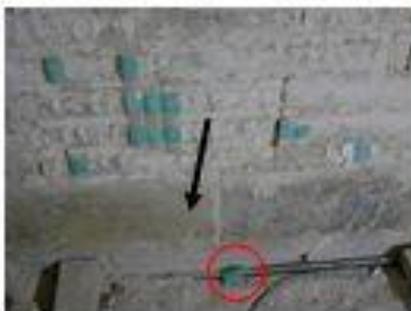
Fig. 7 shows high moisture and crystallization of salts in the supported walls

The results showed that the faience tiles suffered from high alteration because of rising damp in the supported walls and crystallization of soluble salts. Failure of faience tiles is most commonly water related where the units are highly susceptible to glaze cracking, spalling and material loss. Also when a glass or glaze is subjected to weathering by action of water, the alkali ions ( $\text{Na}^+$  and  $\text{K}^+$ ) are replaced by hydrogen ions ( $\text{H}^+$ ) and the glass network progressively breaks up. Thus, the silica glass structure is lost and replaced by amorphous layer so-called silica gel. In addition to leaching out of the alkalis, there are also some leaching out of the colorants which will no longer be present as ions but will have been deposited as fine amorphous or poorly crystalline compounds resulted in the change the chemical composition of faience surfaces (Schreiner et al., 1999; Huisman et al., 2008; Tite et al., 2009). Porous faience tiles can also deteriorate due to the presence of soluble salts within the body itself where the salts dissolve and re-crystallization. The binding mortars suffer from failure and fragile due to chemical alteration (Dotter, 2010) resulting of high content of moisture and crystallization of salts where the mortar has always been the key to the survival of ceramic tiles (Wilson, 1984). Limestone supported walls of faience tiles also suffer from salts crystallization. Salts may be carried into the stone with groundwater by capillary rise (Figueired et al., 2010) or may be dissolved from the mortar joints, or result from chemical reaction between atmospheric pollutants (especially  $\text{SO}_2$ ) and minerals (such as calcite ( $\text{CaCO}_3$ ) in the limestone). If salts precipitated beneath the material of surface (a phenomenon called subflorescence or cryptoflorescence) severe damage can be induced (Espinosa-Marzal et al., 2010). The results determined also the human deterioration phenomena due to the human negligence which observed on the careless of the faience tiles

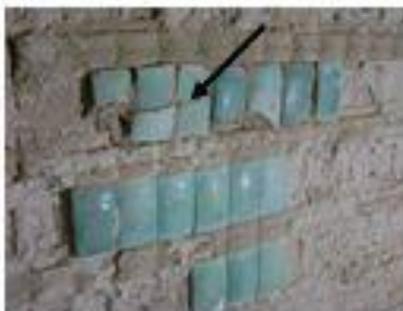
Fig. 8 shows crazing and cracking on the surfaces of faience tiles.

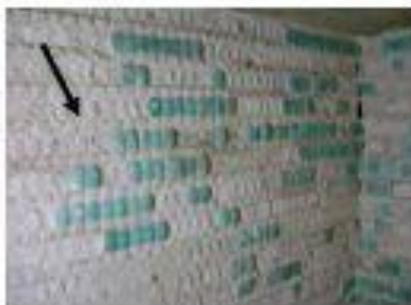
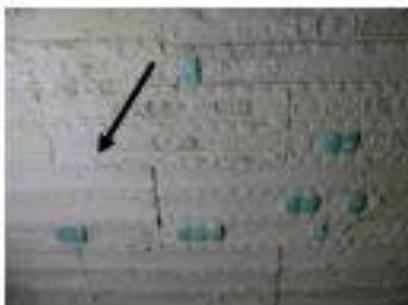
Fig. 9a, b shows fall of many faience tiles from the supported walls.

at the tomb. Because of negligence and absence of the periodical maintenance and conservation procedures, many tiles fall off from their supported walls and sometimes lost completely.

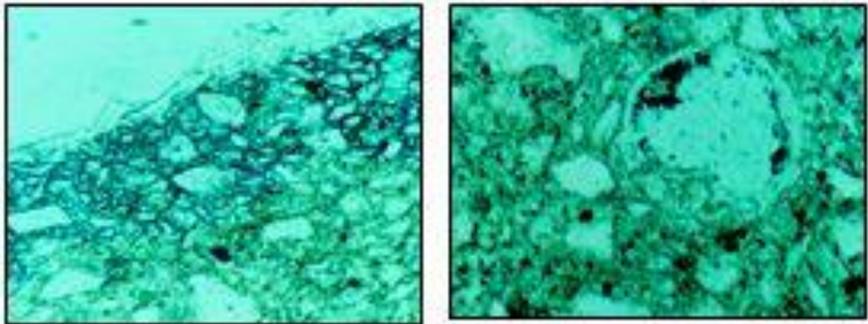
Different samples of faience tiles and limestone supported walls were examined by using polarizing microscope. Cross sections of faience tiles shows that the components of faience tiles are a mixture of crushed quartz or sand with a small amount of lime. The quartz was appeared as angular grains and also we can see the pores and cracks through the body matrix which appear in black colour. A copper compound and alkali flux (natron or plant ash) appeared through the blue glazed layer which penetrated through porous body of the faience (fig. 10). Thin sections of limestone supported walls show that limestone consists of mainly fine-grained calcite crystals (biomicrite) besides presence of iron oxides, quartz, clay minerals and fossils (fig. 11).

Fig. 10. Cross section photomicrographs showing mixture of crushed quartz which appeared as angular grains and also we can see the pores and cracks in the body matrix which appear in black colour

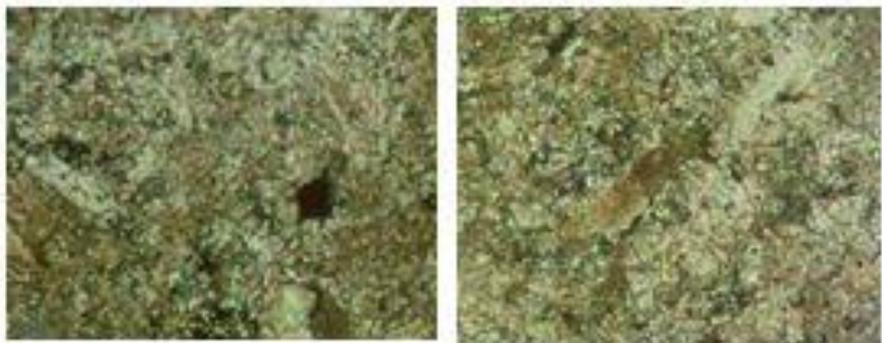
Fig. 11. Thin section photomicrographs showing iron oxides, clay minerals, fossil and grains of quartz in a mass ground of fine- grained calcite. 36X (C.N).

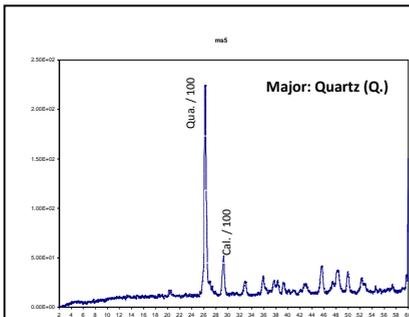
X-ray diffraction results of faience tiles samples shows that this sample consists of quartz mineral and calcite mineral, in addition to halite mineral as a salt (Fig. 12).

Fig. 12 shows XRD pattern of bodies of faience tiles.

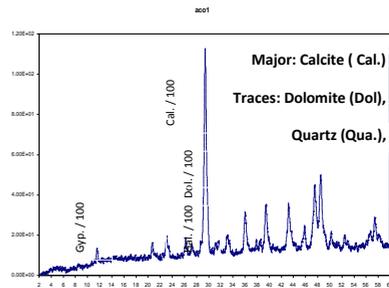
X-ray diffraction data of supported walls sample shows that the sample consists of mainly calcite, dolomite, halite, quartz and gypsum (Fig. 13).

Fig. 13 shows XRD pattern of supported limestone walls.

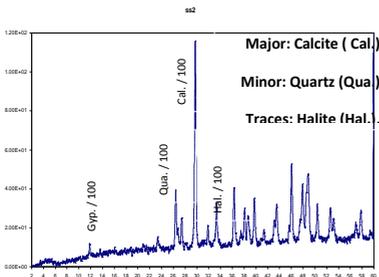
Fig. 14 shows XRD pattern of building mortar.

Data of X-ray diffraction of building mortar shows that the sample consists of mainly calcite, quartz, gypsum, in addition to traces of halite as a salt (Fig. 14). Fixing mortar of faience tiles consists mainly of calcite, quartz, gypsum besides of halite mineral as a salt (Fig. 15).

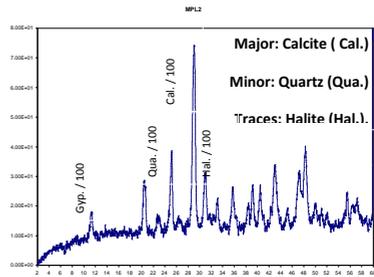
Fig. 15 shows XRD pattern of faience tiles mortar.

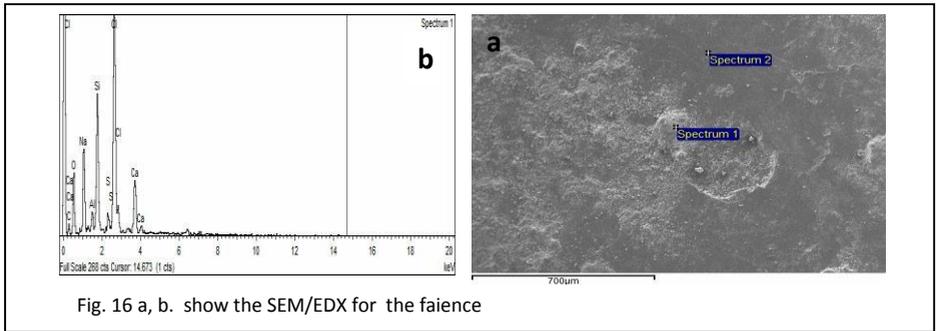
Many samples including samples from the body of faience tiles, mortars and supported walls investigated and analyzed by scanning electron microscopy coupled with EDX microanalysis. Investigation by SEM of the body sample showed the erosion and disintegration of the faience by the salt crystallization (fig. 16a), whereas EDX analysis of the same location contains the elements of each chloride (Cl) and sodium (Na) with high ratio. This indicates

that the faience tiles deteriorated by the crystallization of sodium chloride salt, in addition to leaching of the alkaline compounds from the core of faience to the surfaces (fig. 16b). The result analysis of the colored surface showed the presence of elements of silicon (Si), copper (Cu) (fig. 17a, b, c) and this indicate that a copper compound was used to obtained the turquoise blue colour in an oxidizing atmosphere (Hatton et al., 2008; Tite et al., 2009). The presence of sodium, magnesium and calcium elements indicate that weathering process was occurred according to (Oakley, 1989; Huisman et al., 2008; Tite et al., 2009) by action of water where the alkali ions ( $\text{Na}^+$  and  $\text{K}^+$ ) are replaced by hydrogen ions ( $\text{H}^+$ ) (fig. 17d). The mortar which used to fix the faience tiles have been analyzed and the results showed that it contains mainly both of chloride (Cl) and sodium (Na) elements and this indicate that this mortar contains high ratio of sodium chloride salt NaCl (fig. 18a, b, c, d). Regarding to the kind of building mortar used, the results were proved that it was consisted of lime and quartz (as aggregate), in addition to few amounts of sodium, aluminium, potassium and iron (fig. 19a,b). (Elert et al., 2002). The supported wall analysis showed that it is limestone where it contains mainly calcium (Ca), few contents of silicon (Si) and iron (Fe) (fig. 20a, b, c).

Fig. 16 a, b. show the SEM/EDX for the faience

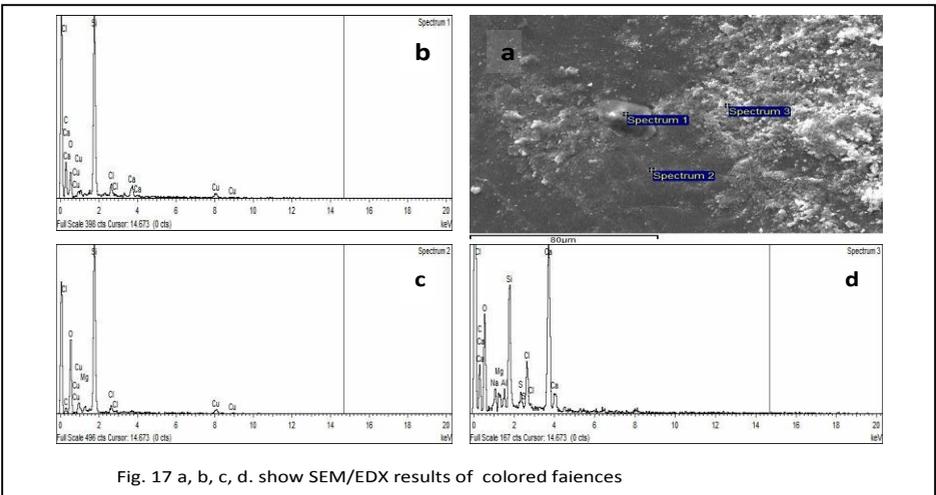
Fig. 17 a, b, c, d. show SEM/EDX results of colored faiences

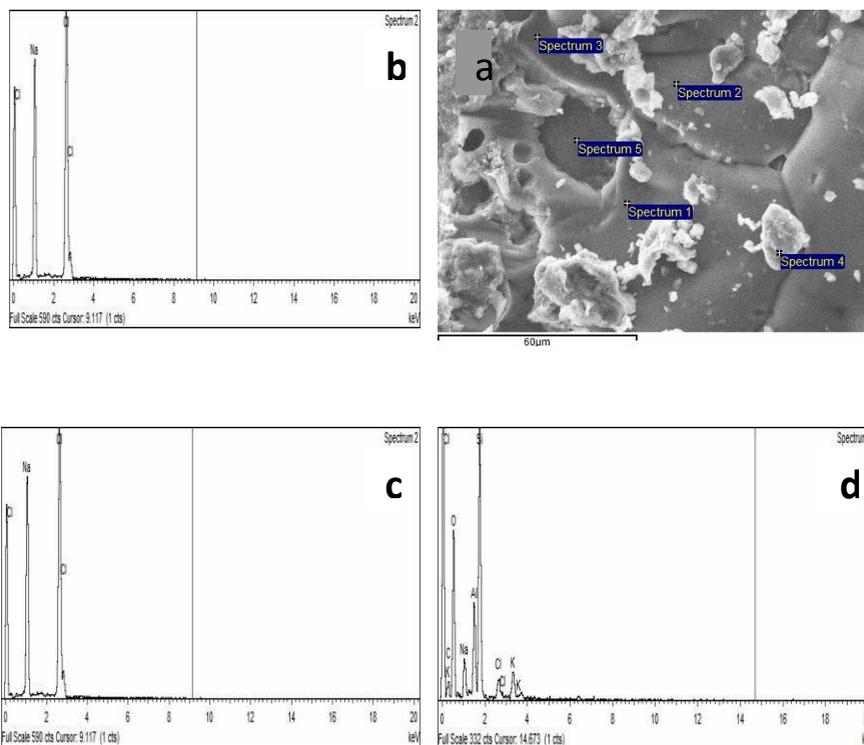
Fig. 18 a, b, c, d. show SEM/EDX results of mortar.

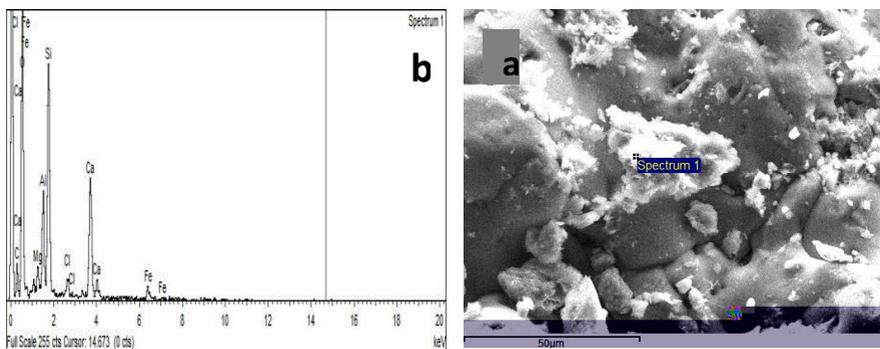
Fig. 19 a, b. show SEM/EDX results of building mortar.

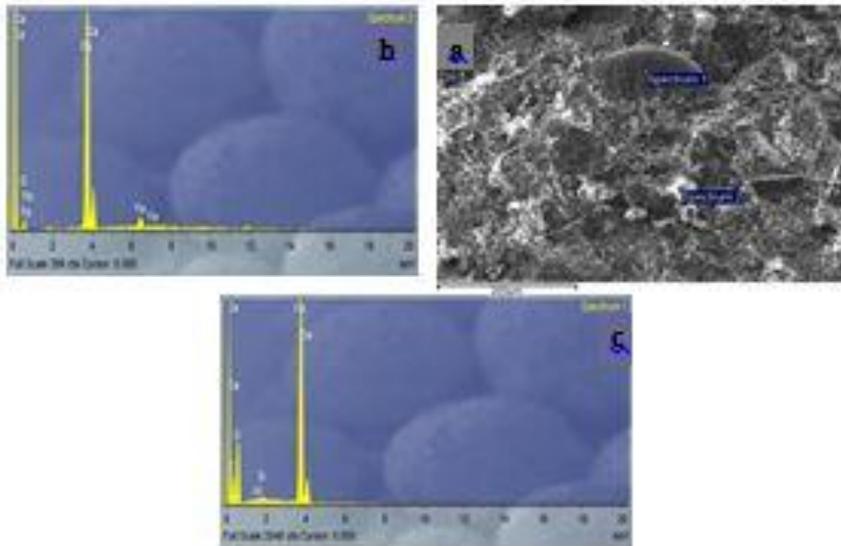
Fig. 20 a, b, c. show SEM/EDX results of supported walls.
